Re: Revisions and Incorporation of Technical Panel inputs to :
Progress Report 2. *Evaluation of Organic Matter Addition and Incorporation on Steep
Cut slopes, Phase II: Test Plot Construction and Performance Monitoring*

Quarterly Progress Report #2
For the period October 1, 2003 – December 31, 2003

**EVALUATION OF ORGANIC MATTER ADDITION
AND INCORPORATION ON STEEP CUT SLOPES**

***Phase II: Test Plot Construction and
Performance Monitoring***

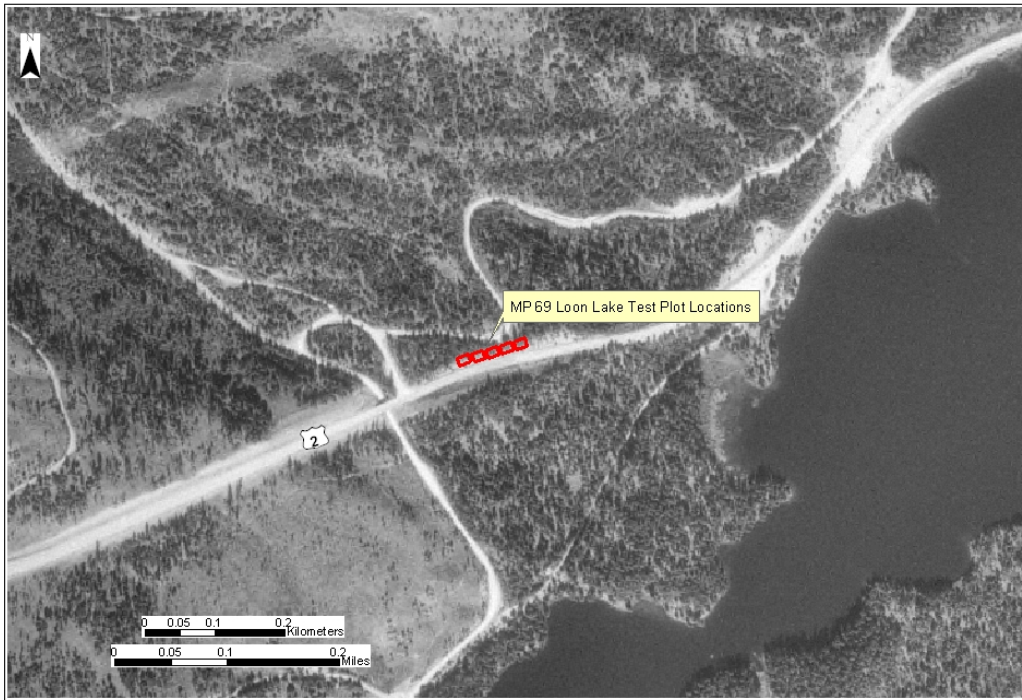
Figure 5. Location of MP69 (Loon Lake) research site.

The MP69 site is located on the north side of U.S. Highway 2 immediately northwest of Loon Lake (Figure 5). The site is characterized by very coarse textural class material with abundant boulders and cobbles (Figure 6). Mean rock content (> 2 mm) was 63.5 percent (Table 4). All plots at this site were 15.24 m square (232.2 m^2) with 3 m buffer zones between plots (Figure 7).

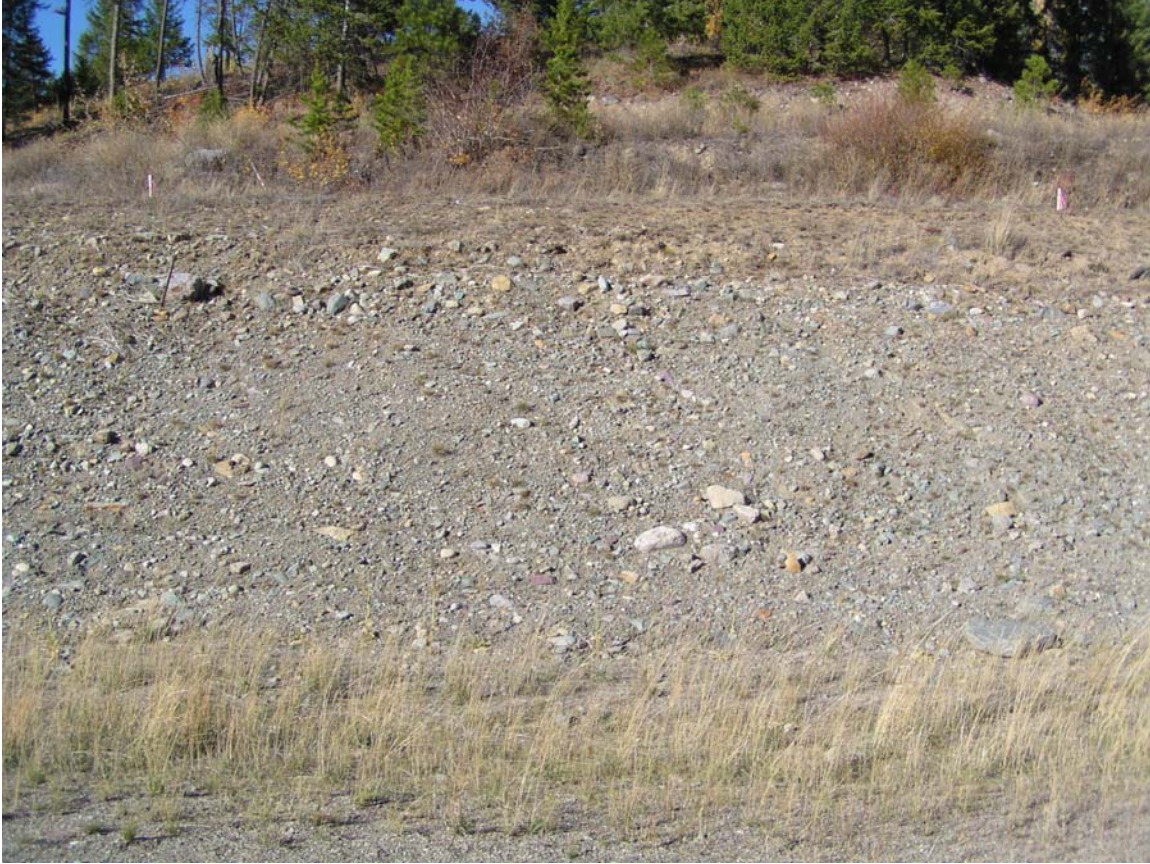
Figure 6. MP69 (Loon Lake) research area preconstruction conditions, Plot 8.

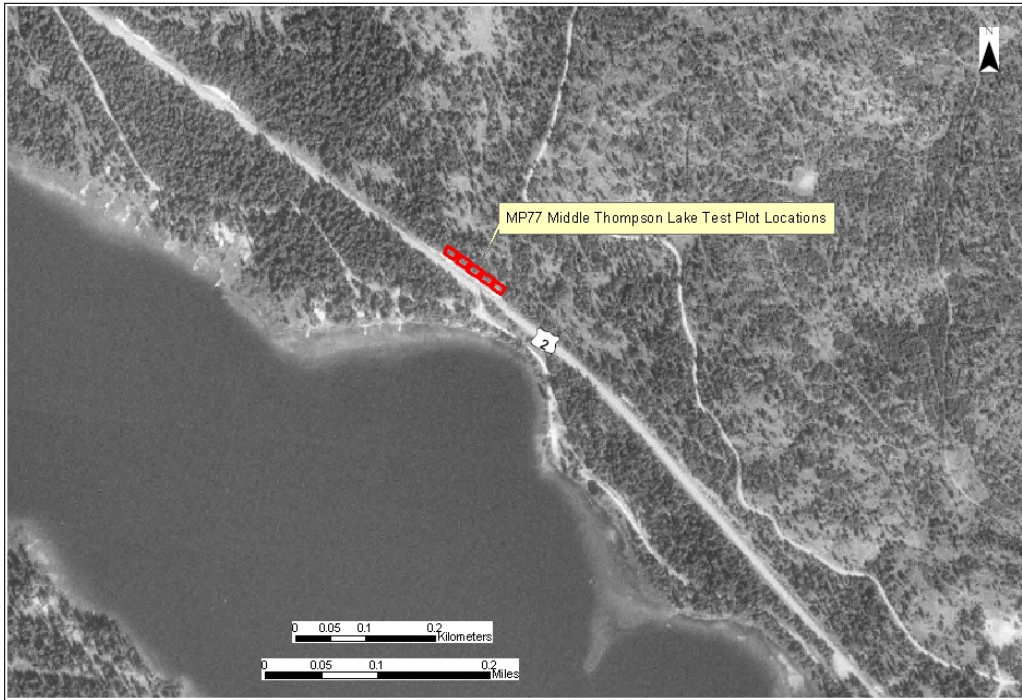
Figure 8. Location of research plots at MP77 site, adjacent to Middle Thompson Lake.

The MP77 site is located along the north side of U.S. Highway 2 adjacent to Middle Thompson Lake (Figure 8). Geologic materials consist of fine textural class sediments that are assumed to be glacial lake sediments. Alden (1953) stated that “Cuts on the new grade of U.S. Highway No. 2 along the north side of the Thompson Lakes, examined in June 1937, gave fine exposures (at about 3,400 ft above sea level) of 20 to 25 ft of finely laminated buff to brownish, rather plastic lacustrine silt. In some of the cuts in these beds have been disturbed by slumping and in some the silt overlies gravel. The silt was evidently deposited in a glacial lake bordering the front of the melting Cordilleran ice.” Typically, these materials have very little rock content (Table 5). The lacustrine silts have proven troublesome to revegetate following construction and vegetation was sparse at this site with a notable accumulation of sediment in roadway drainage ditches (Figure 9). One of the primary erosion mechanisms occurring in these silts appears to be the slumping of saturated surface layers that overlie frozen substrate during spring thaw cycles.

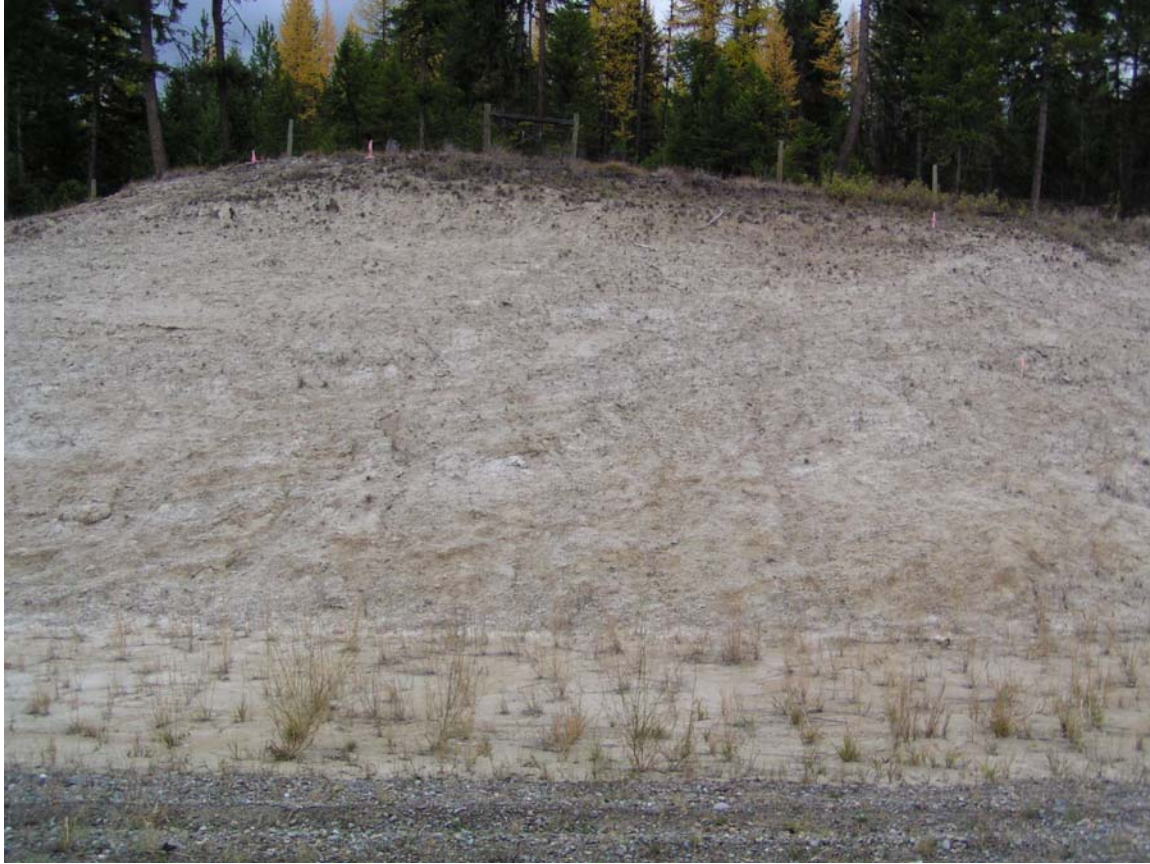
Figure 9. Research Plot 1 at the MP77 site prior to plot implementation. Note accumulated sediment in ditch, rills, and the general lack of vegetation cover.

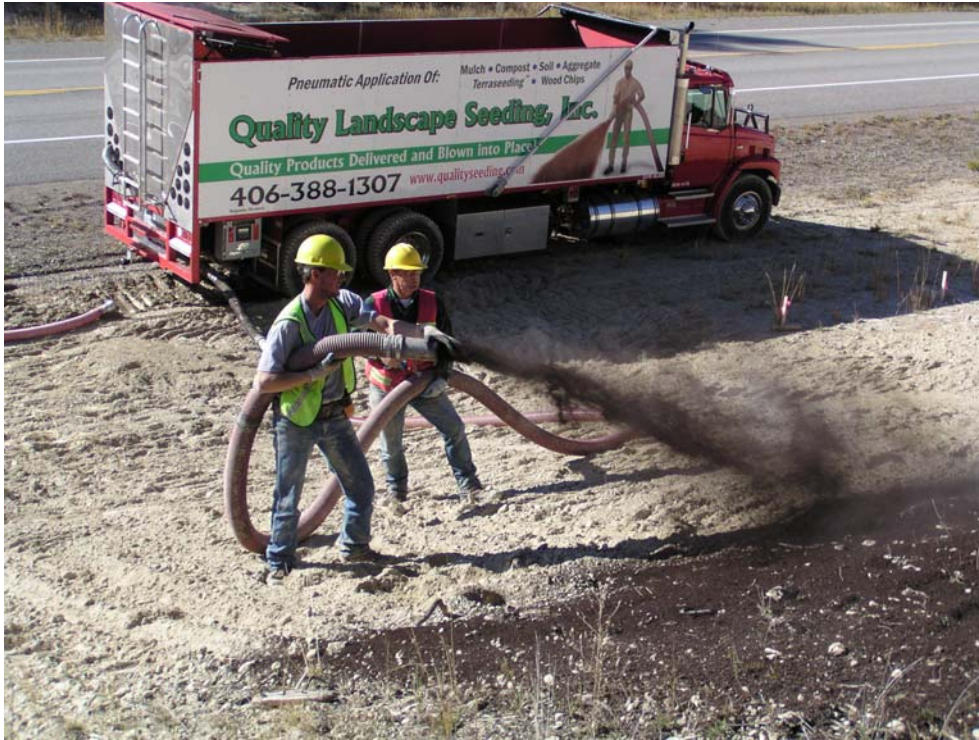
Figure 11. Express Blower Model EB-30 applying compost at the MP77 site.

The blower truck experienced no difficulties applying compost to the research plots (Figure 11). The maximum length of the research plots was only 10 to 20 percent of the capability of the truck (standard hose length is 111.6 m or 366 feet) and no clogging of feeders or blower hose occurred. Minor hand shoveling inside the truck box was required to feed compost to the walking floor when the unit was near empty. This was apparently caused by the tilt of the unit produced by stationing it partially in the borrow pit to maintain a clear traffic lane. Compost application was timed for several plots. Approximately 10 minutes was required to apply a controlled 1.3 cm compost layer on each plot and an additional 15 to 20 minutes to apply the remaining 3.8 cm of compost on the 5.1 cm treatments for an approximate rate of 0.05 ha/hr (Table 7). These rates should not be construed as the expected rate on a full scale project. Due to the size of the research plots, more time was required to ensure the applied compost was within plot boundaries. The application of two specific compost layers increased application time by about 10 percent. Manufacturer literature suggests normal

application rates of 0.76 to 1.53 m³ (1 to 2 cubic yards) per hour. At the higher rate, a 5.08 cm compost blanket would be applied at 0.18 ha/hr.

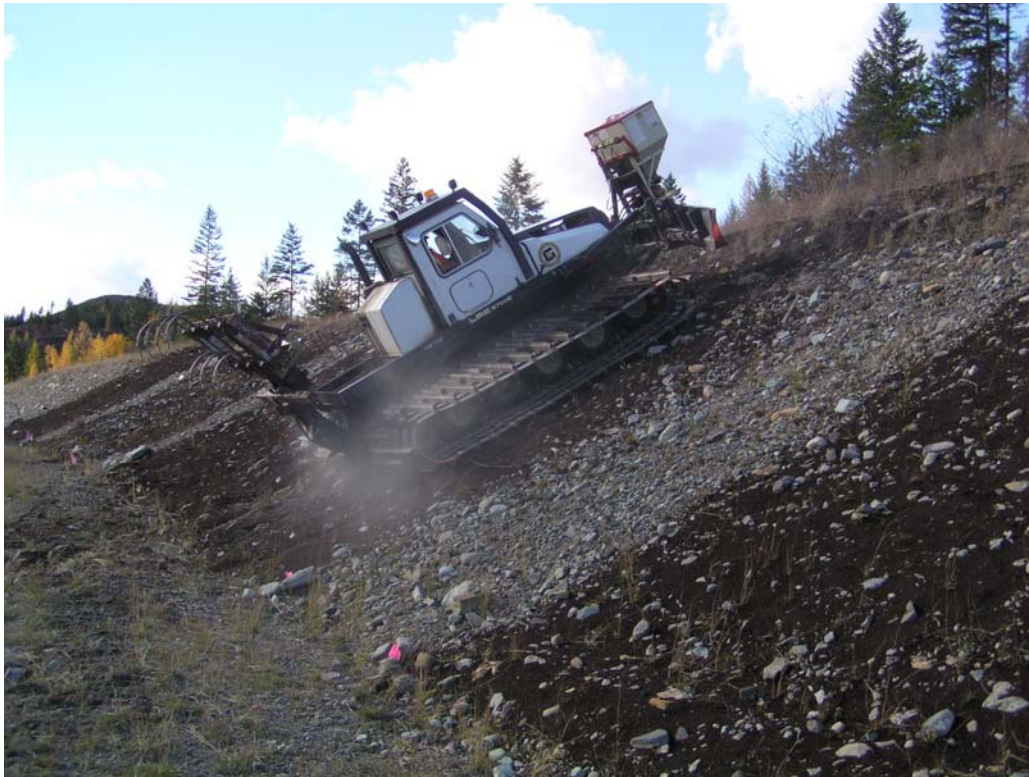
Figure 12. Modified LMC 3700C initiating tillage on plot 8, MP69 site.

The snowcat utilized for this project was a modified LMC 3700C (Figure 12). This unit is powered by a Caterpillar 3208 diesel engine rated at 165 kw (225 hp) and weighs approximately 8160 kg (18,000 lbs). Modifications to this unit were:

- Reinforced undercarriage,
- Upgraded cooling system,
- Solid rubber boggy wheels,
- Pisten Bully drive sprockets and 2.5 m wide steel tracks,
- Rear 3-point quick hitch,
- Front 3-point brackets to mount broadcast seeder, and
- MSHA certified ROPS canopy.

The snowcat had more than sufficient power to use the chisel plow while traversing upslope at both research sites. The performance of the unit was excellent on the fine textured materials at MP77. Traction was very good in the silt dominated material at this site and the operator had very good control of induced track slippage (for additional tillage/mixing action) and very good

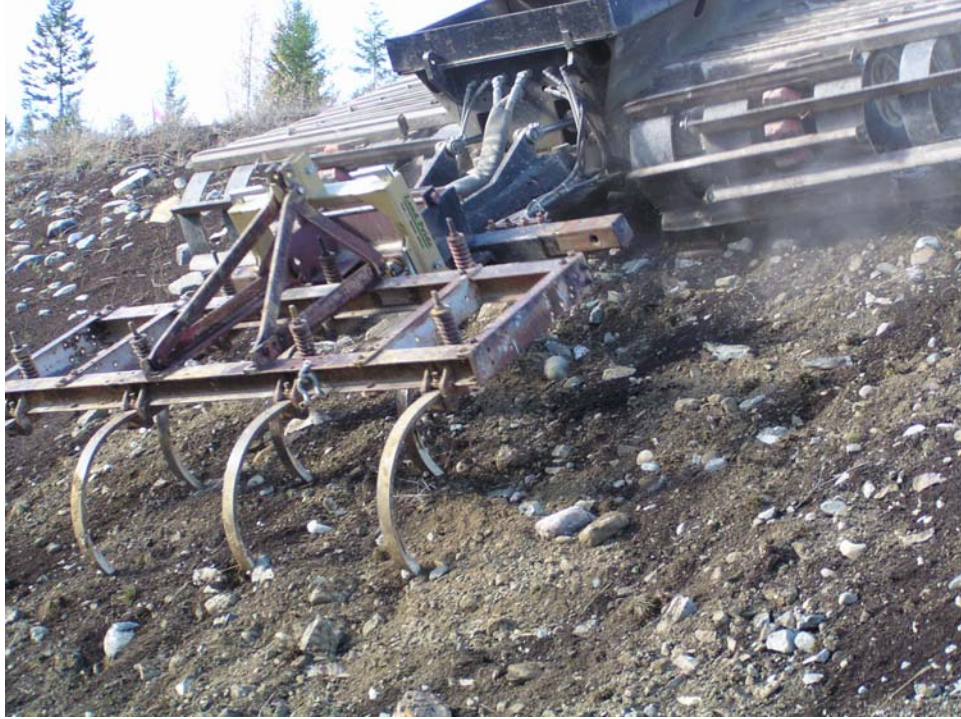
Figure 13. Graham Hoeme 2.4 m (8 ft) spring shanked chisel plow at MP69.

The Graham Hoeme chisel plow utilized for this study worked equally well in both coarse and fine textural classes of material (Figure 13). Shank spacing was set at 0.35 m (1.1 ft) for the 2.4 m (8 ft) wide implement. Potential tilling depth was well in excess of the specified 10.2 cm (4 in) compost incorporation depth for this project. No breakage or other problems were encountered with this unit. It is likely that a wider implement of similar design could have been utilized, especially at the MP77 site.

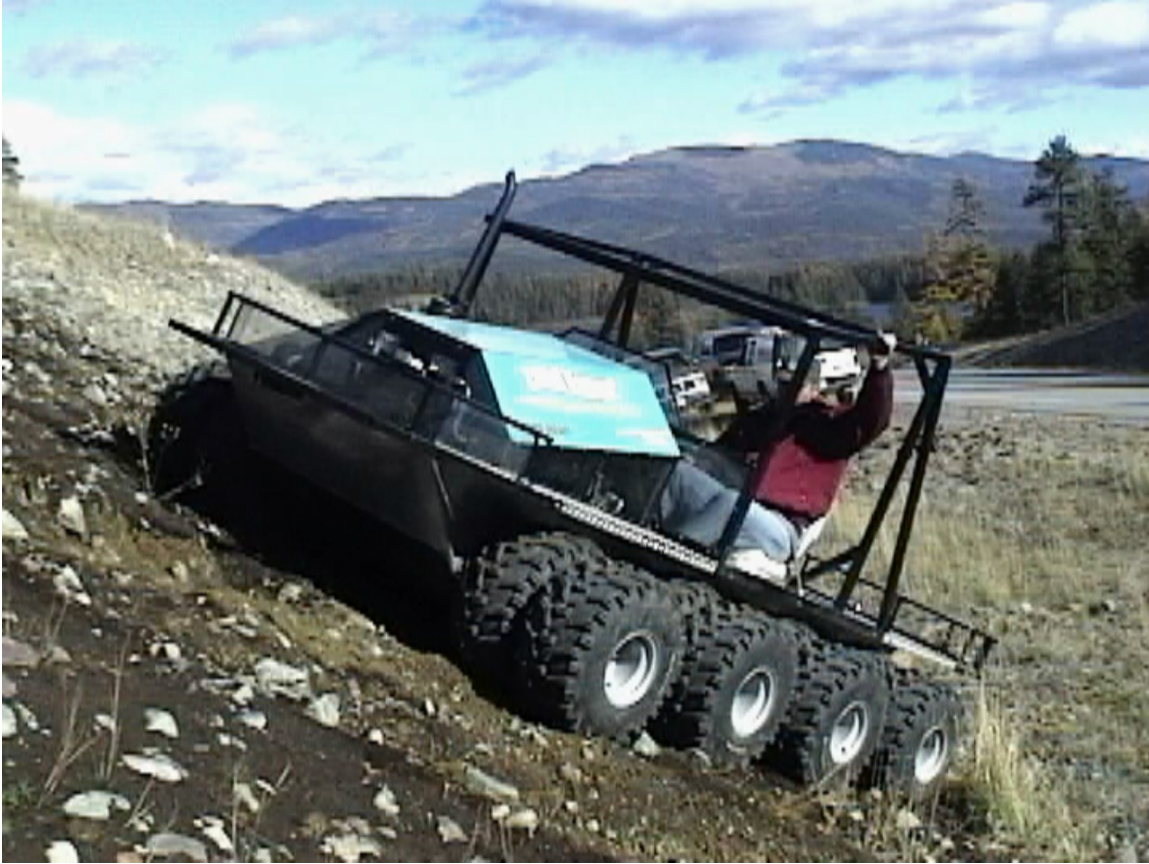
Figure 14. Land Tamer industrial model LT adjacent to MP69 research site.

PFM Manufacturing provided a standard industrial LT model for demonstration purposes at the MP69 site (Figure 14). This unit is a diesel powered eight-wheeled vehicle utilizing a hydrostatic drive. While this machine had no trouble traversing the 50 percent slopes at MP69, either on the contour or at an angle, it suffered from problems similar to the snowcat. Its rigid suspension limited wheel contact when riding over large cobble and boulders. The resulting loss of traction was sufficient to prevent direct traverse up slope at this site even without any tillage implements. The Land Tamer was not demonstrated at the MP77 site. It is the authors' opinion that this unit would have performed acceptably well on the silt-dominated materials using a small tillage implement.

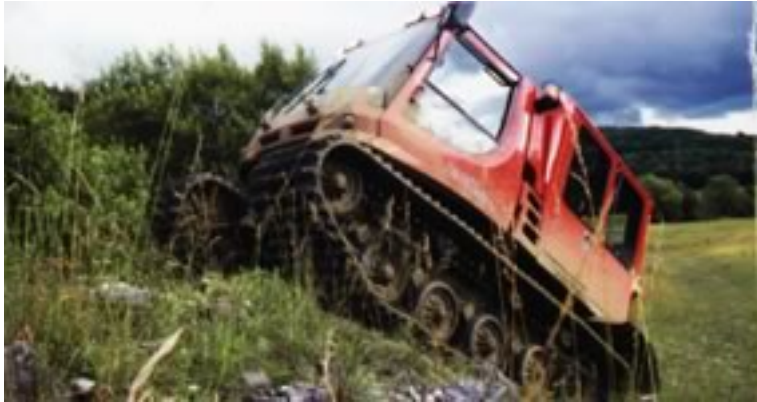
Figure 15. Pisten Bully model 100 Flexmobil (Kassbohrer Gelandefahrzeug AG photo).

Pisten Bully introduced a new “dry ground” model in 2003. This is the Pisten Bully 100 Flexmobil that does include an advanced suspension (Figure 15). Although this machine is less powerful than the modified LMC 3700C used in this study, it may be better adapted to conditions such as found at MP69.
